Manhole Inspection Summary

Manhole # S37WW_015MH

Insp Date: **1/17/07 12:02 PM**

Location Address: **808 MONTPELIER ST**

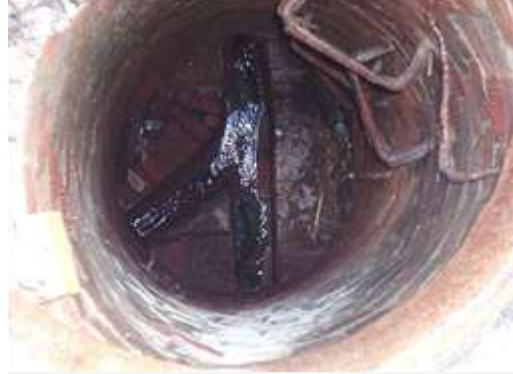
Top View

Corroded steps. Evidence of surcharge - Bench debris. Channel debris.

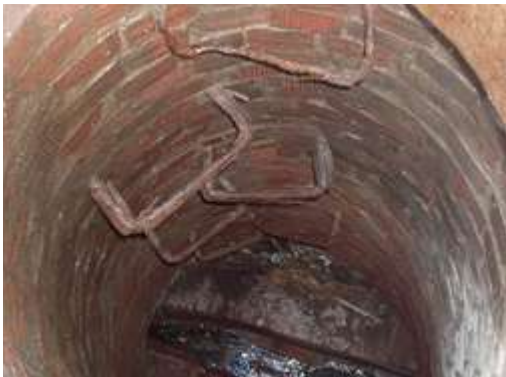
Defect

Corroded steps.

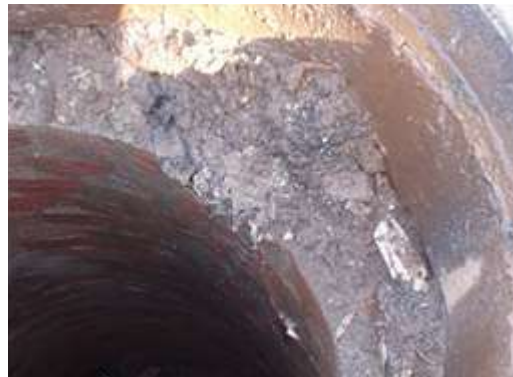
Defect

Frame leaks. Frame offset. Adjustment deterioration and infiltration.

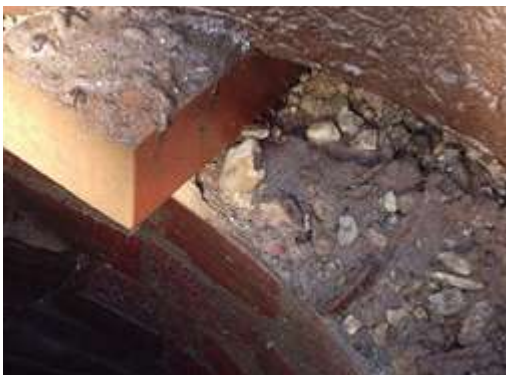
Defect

Frame leaks. Adjustment deterioration, loose brick and infiltration.

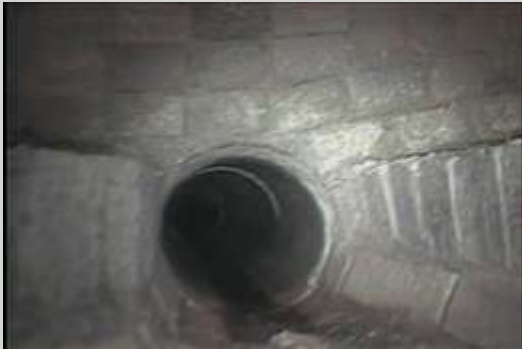
8 in. Circular Gravity Sewer Pipe Out @ 12 O'Clock

Infiltration: **None** Pipe Seal Cond: **Unknown**

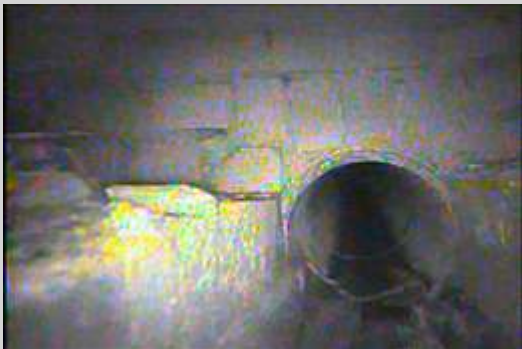
8 in. Circular Gravity Sewer Pipe In @ 6 O'Clock

Infiltration: **None** Pipe Seal Cond: **Unknown**

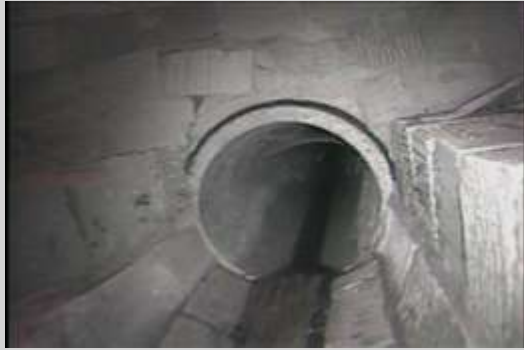
Pipe In @ 8 O'Clock

Infiltration: **None**

Pipe Seal Cond: **Unknown**
